O.M.T. Inspections, LLC

Property Inspection Report

123 Sample Report Ave, Wichita, KS 67111
Inspection prepared for: John Doe
Date of Inspection: 9/4/2019 Time: 2:00 PM
Age of Home: 1998 Size: 2937

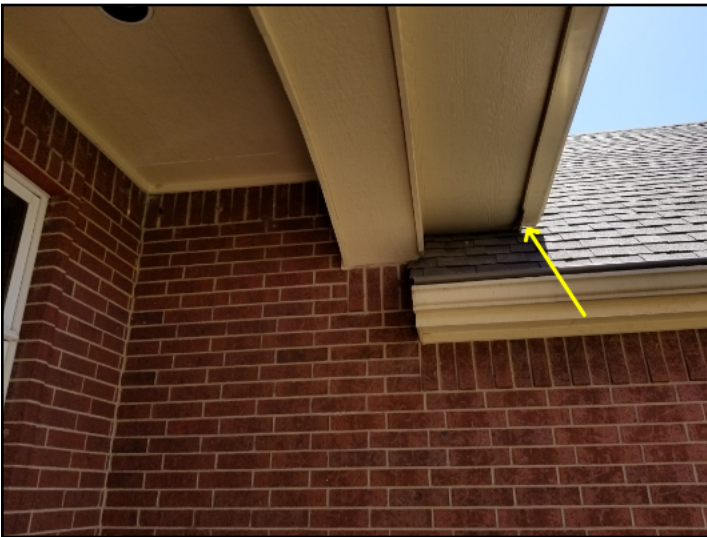
- Minor caulking and painting around the house was needed as part of routine maintenance. It is recommended to have a qualified contractor address.
- Minor cracking noted in the brick above the garage doors at the time of the inspection. It is recommended to have a qualified contractor repair as needed.
- **Some deteriorated fascia and soffit noted around the house at the time of the inspection. It is recommended to have a qualified contractor evaluate and repair as needed prior to close.**

Example of fascia deterioration.

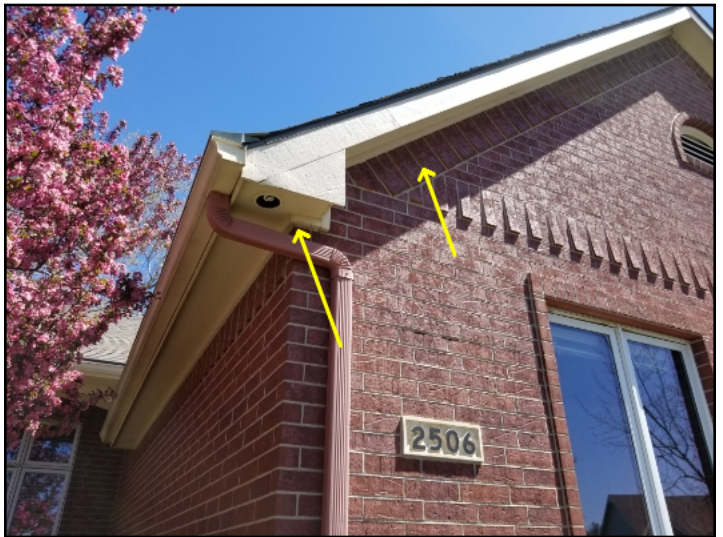
Example of deteriorated fascia.

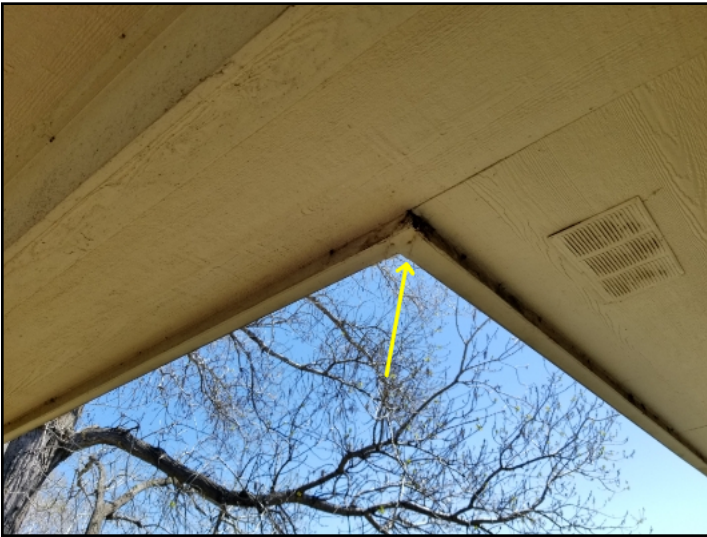
Example of deteriorated fascia.

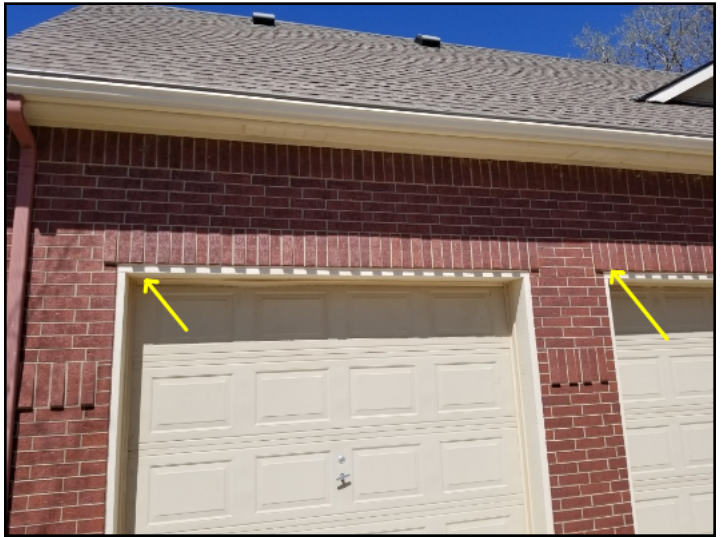
Example of minor cracking in the brick above the garage.

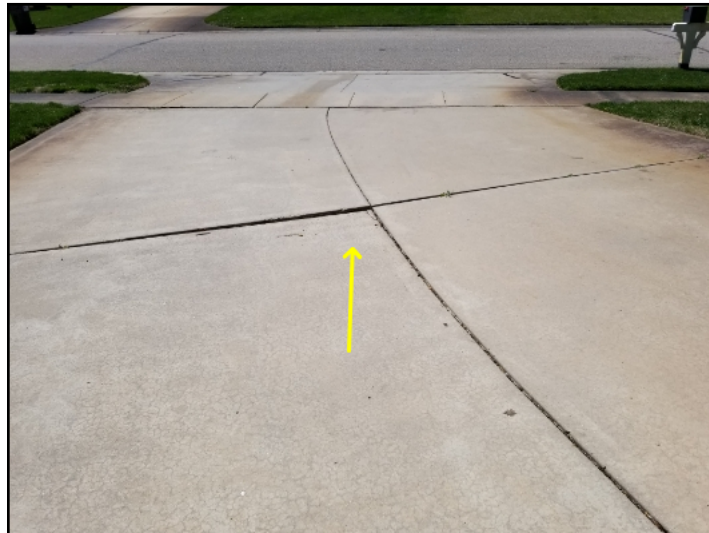
- Multiple uneven slabs were noted on the driveway and walkway at the time of the inspection. These slabs were displaced enough to be causing a tripping hazard. It is recommended to have a qualified contractor repair/replace as needed for safety.

Example of tripping hazard.

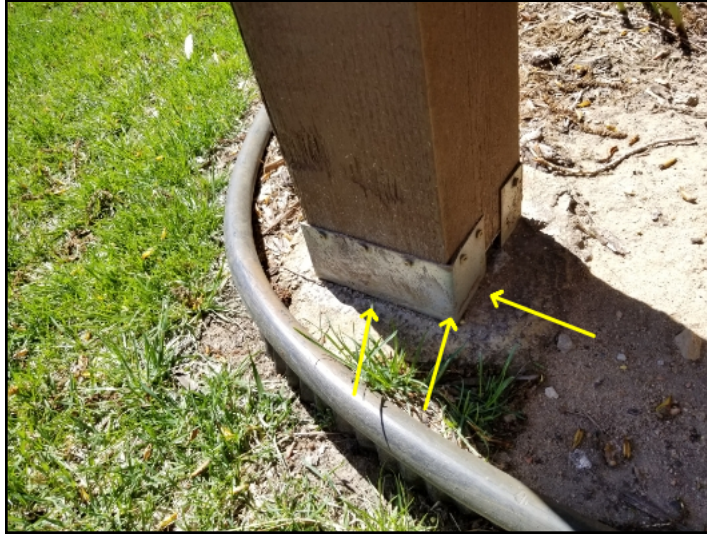
- No joist hangers were noted on the deck. This is a non typical install. It is recommended to have a qualified contractor review the deck construction for the need of joist hangers and install if deemed needed.
- Some of the post to bracket connections on the stair structure were attached with screws at the time of the inspection. These are not approved structural fasteners. It is recommended to have a qualified contractor replace with an approved fastener.

Deck screws are not approved structural fasteners.

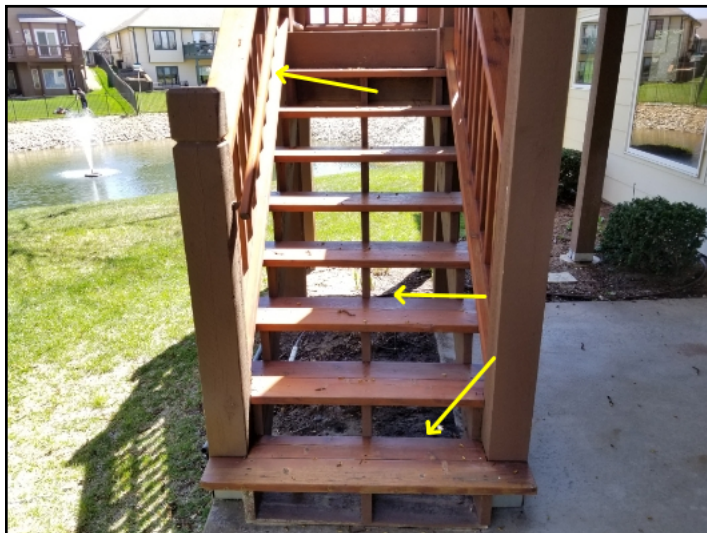
- Safety upgrade: The steps to the deck had open risers greater than 4 inches. The **AHJ** allows this practice in the area. However this can be a safety hazard and it is recommended that all steps should be closed in.
- An uneven rise was noted on the deck stairs at the time of the inspection. This is a tripping hazard. It is recommended to have a qualified contractor repair/replace as needed for safety.
- The east lower railings on the deck stairs were slightly weak and unstable at the time of the inspection. It is recommended to have a qualified contractor repair/replace as needed for safety.

Uneven rise, open risers, and a weak railing.

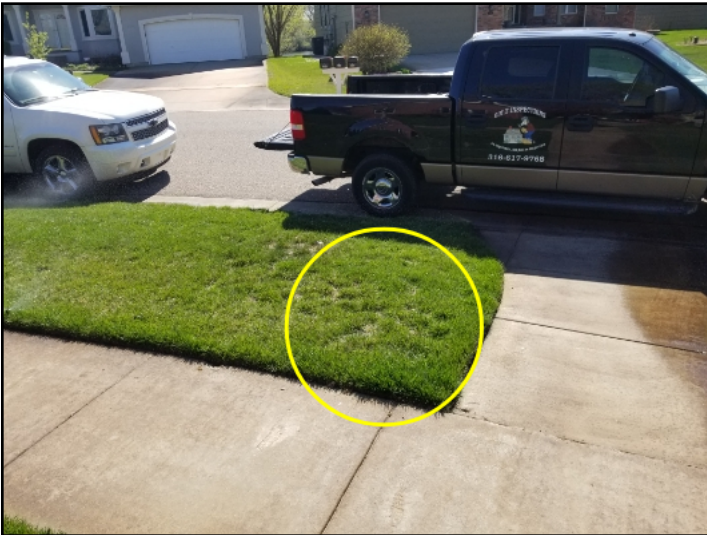
- The sprinkler system operates with a control panel located in the garage.
- Heads on zone 1 and zone 2 appeared to need adjustment to broaden their coverage area. It is recommended to have a qualified sprinkler contractor address.

Area on zone 1 without adequate coverage.

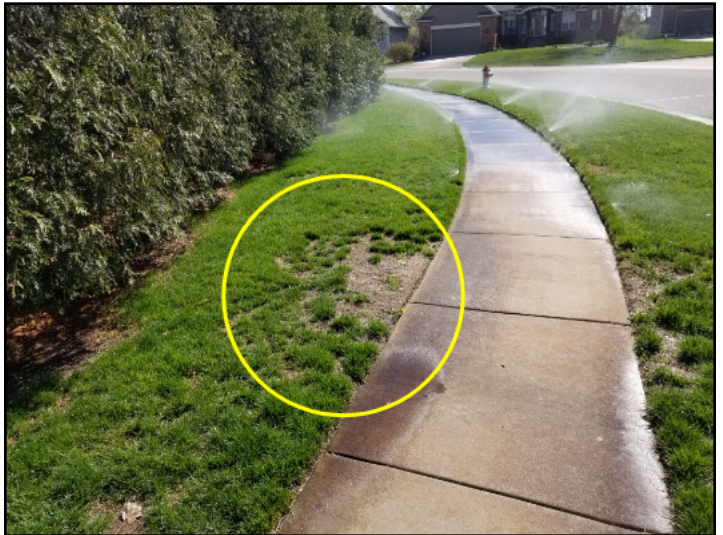
Area on zone 2 without proper coverage.

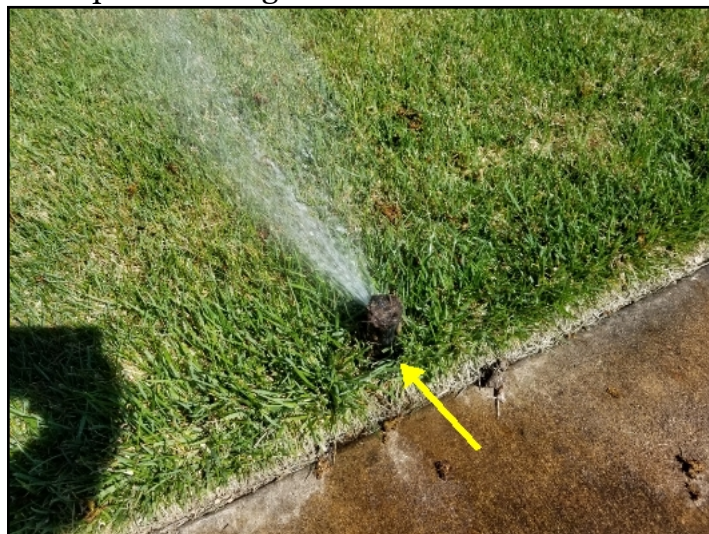
- Sprinkler head on zone 3 near the sidewalk leaked at the time of the inspection. It is recommended to have a qualified sprinkler contractor repair, or replace as deemed necessary prior to close.

Sprinkler head on zone 3 leaking.

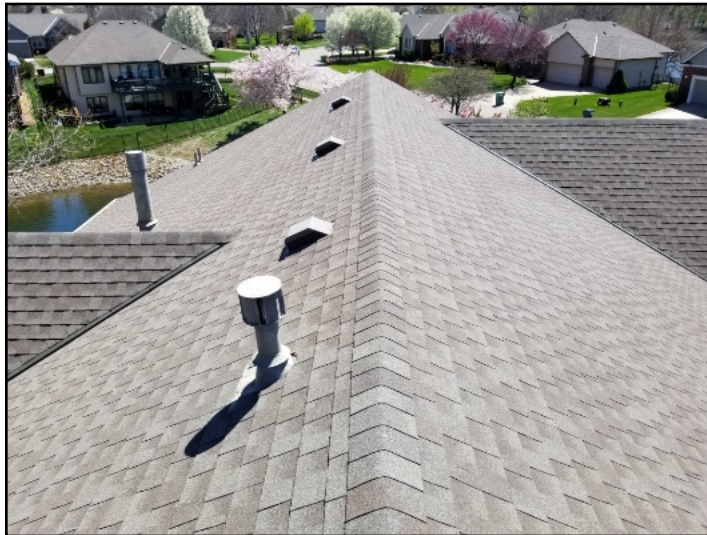
- Some minor granule loss and slight impact damage noted on the roof surface at the time of the inspection. It is recommended to verify the insurability of this roof with the buyers insurance company prior to close.

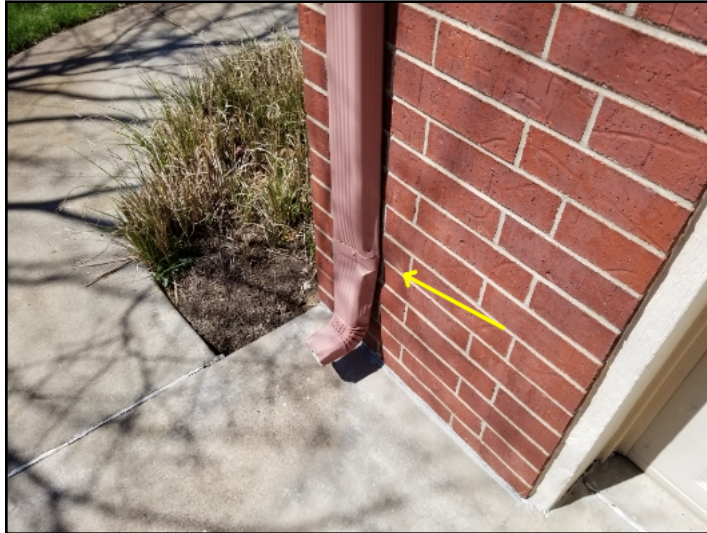
- The downspout on the southwest corner of the house was crushed at the time of the inspection. It is recommended to have a qualified contractor repair or replace as needed.

Example of a crushed downspout on the southwest corner of the house.

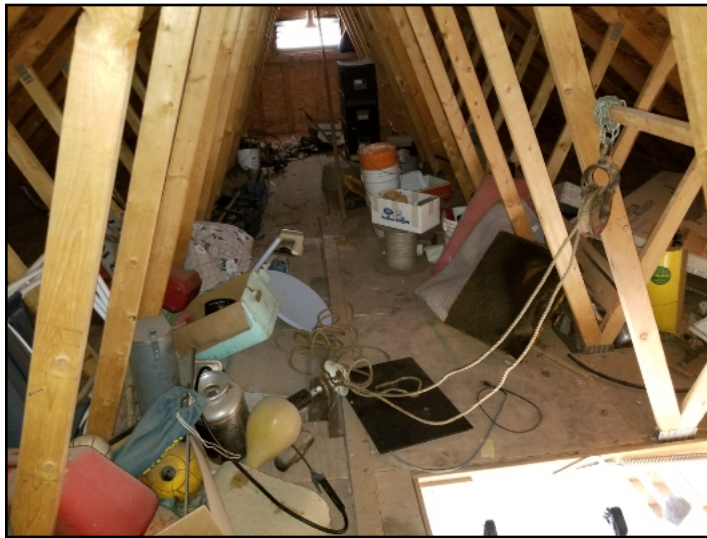
- Attic was partially traversed due to limited walking platforms.
- A significant amount of personal belongings noted in the attic at the time of the inspection. It is recommended to have the sellers remove all personal belongings prior to close.

Personal belongings throughout the attic.

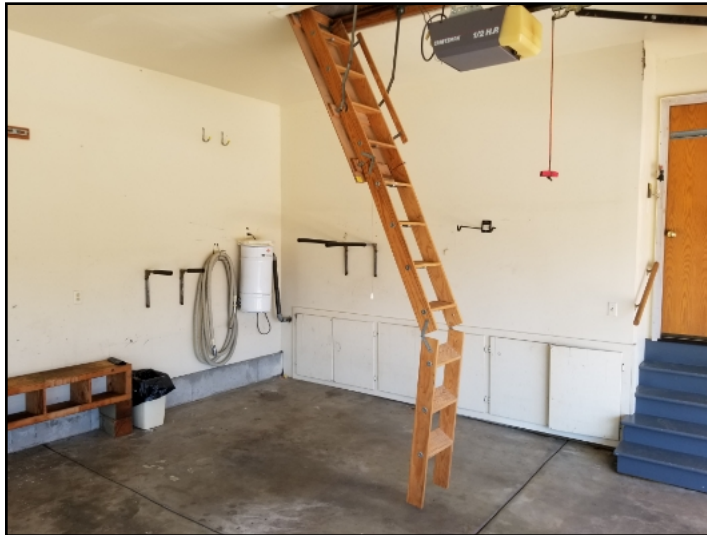
- Pull Down Ladder located in: Garage Ceiling
- The garage attic ladder did not reach the floor at the time of the inspection. It was also not rated for a firewall installation. It is recommended to have a qualified garage door contractor replace with an approved fire rated and properly size ladder.

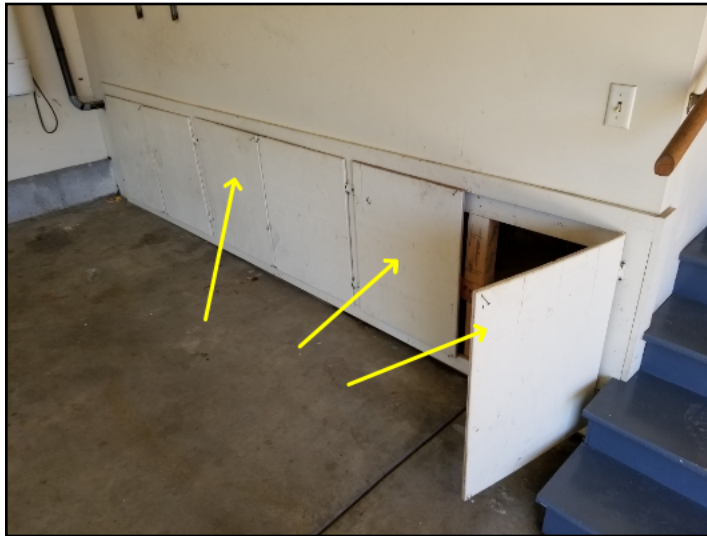
- The garage firewall was damaged/compromised at the time of the inspection. Due to this fire potential to the home is at a greater risk. It is recommended to have a qualified contractor repair the fire rated wall per standard building practices.

The storage in the garage compromises the firewall integrity.

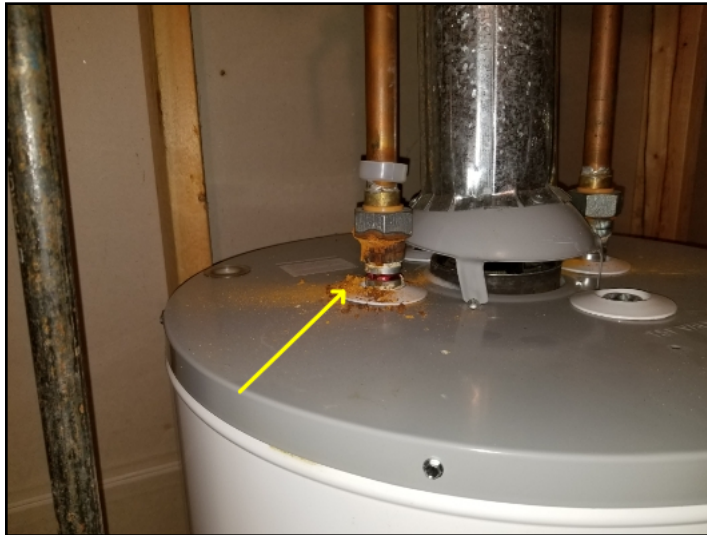
- A supply line fitting above the water heater had evidence of a previous leak. Calcium build up was noted around the fitting and that is evidence of a slow leak. The fitting did not appear to be actively leaking at the time of inspection, however these leaks commonly start to leak at a later date. It is recommended to have a qualified plumbing contractor repair as needed.

Corrosion buildup above the water heater.

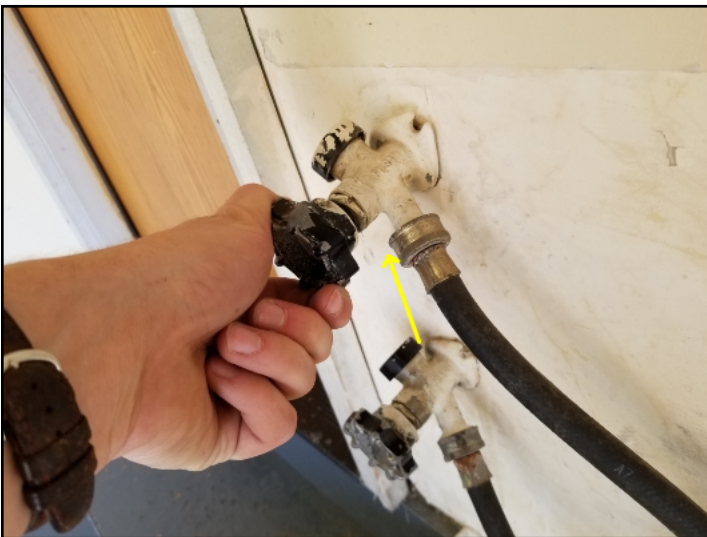
- The sillcock on the west and south was leaking out of the vacuum cap during operation at the time of inspection. It is recommended to have a qualified plumbing contractor evaluate and repair as needed.
- The garage sillcocks leaked during operation at the time of the inspection. It is recommended to have a qualified contractor repair.
- The sillcock on the well was leaking at the time of the inspection. It is recommended to have a qualified contractor repair.

Garage sillcock leaking.

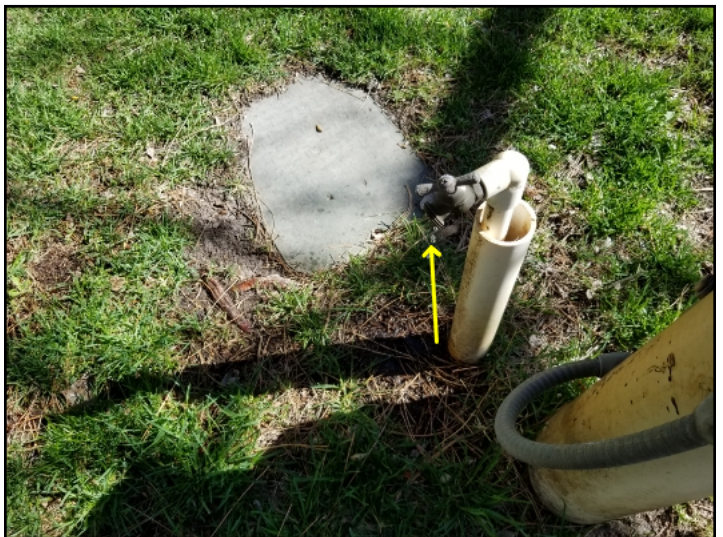
Well sillcock leaking.

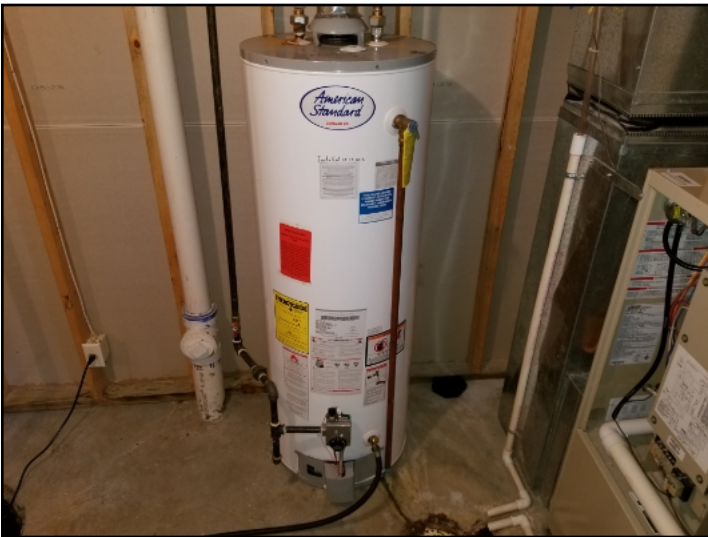
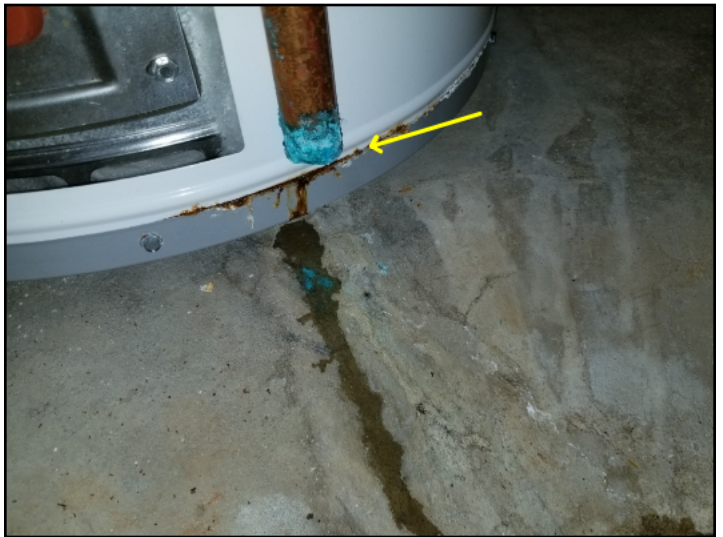
- The water heater was leaking out of the **TPR valve** at the time of the inspection. It is recommended to have a qualified plumbing contractor fully evaluate and repair or replace as deemed needed prior to close.

Water heater leaking out of the TPR valve.

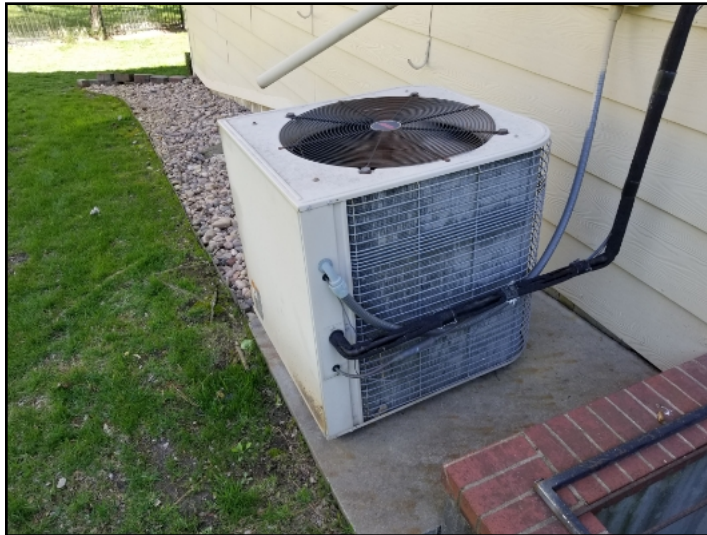
- The exterior condensor was dirty and in need of cleaning as part of routine maintenance. It is recommended to have a qualified contractor address.
- The insulation on the air conditioning condensing unit's refrigerant lines was deteriorated or missing in some areas at the time of the inspection. This may result in reduced efficiency and increased energy costs. It is recommended to have a qualified HVAC contractor replace or install insulation as necessary.

- The exterior unit was not level at the time of the inspection. This can affect system performance. It is recommended to have a qualified contractor relevel the unit as needed.

- The fins on the exterior unit were dented and damaged at the time of the inspection. It is recommended to have a qualified HVAC contractor evaluate and repair as needed.

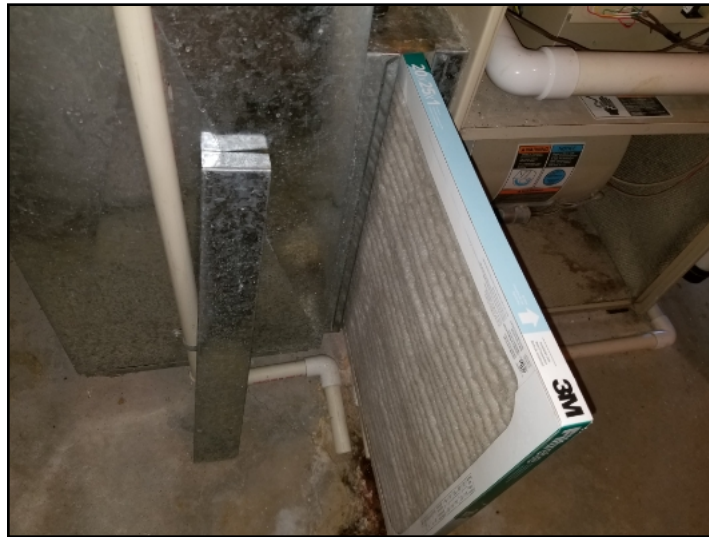
Dirty filter

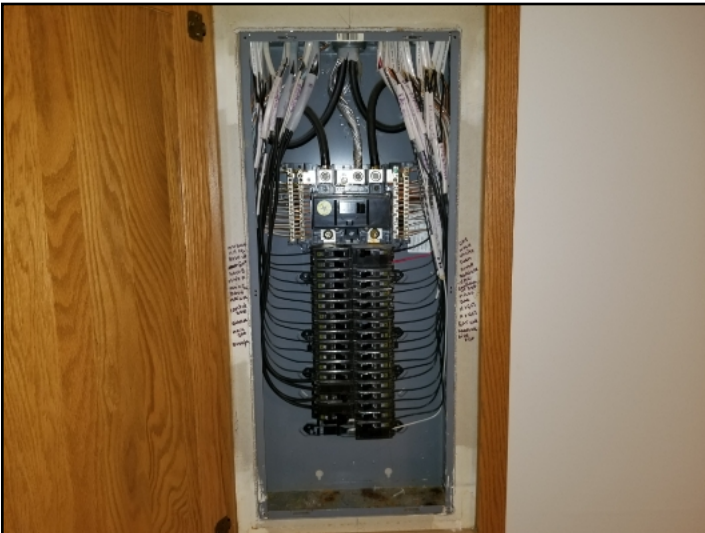
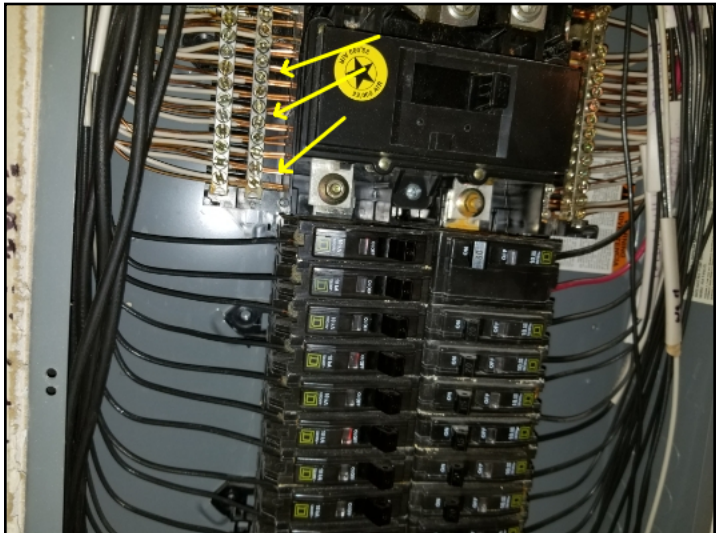
- **Double tapped** neutrals noted in the main panel box at the time of inspection. It is recommended to have a qualified electrical contractor repair per standard building practices.

Example of double tapped neutrals.

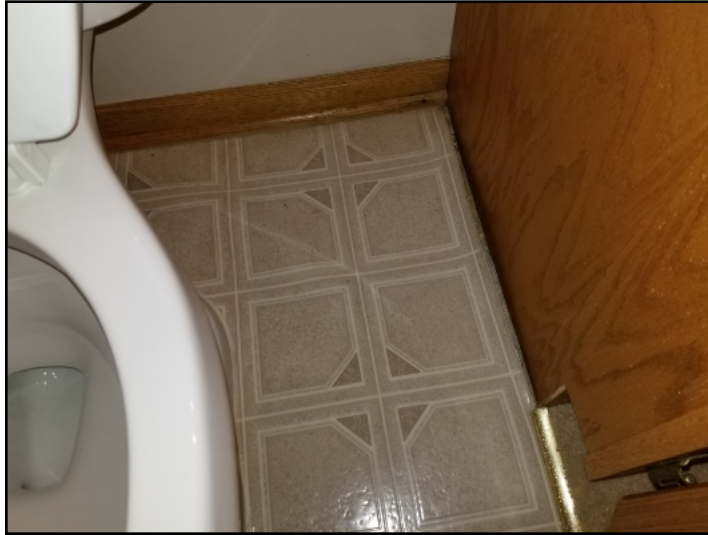
- The linoleum flooring in the basement bathroom appeared to have lost it's adhesion at the time of the inspection. It is recommended to have a qualified contractor to repair, or replace as needed.

Linoleum floor in basement bathroom losing it's adhesion.

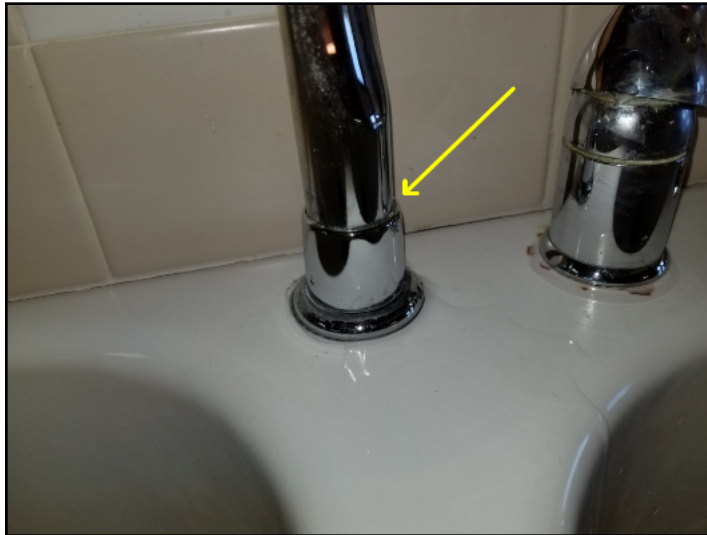
- The kitchen sink faucet leaked at the base at the time of the inspection. It is recommended to repair as needed.

Kitchen faucet leaking at the base.

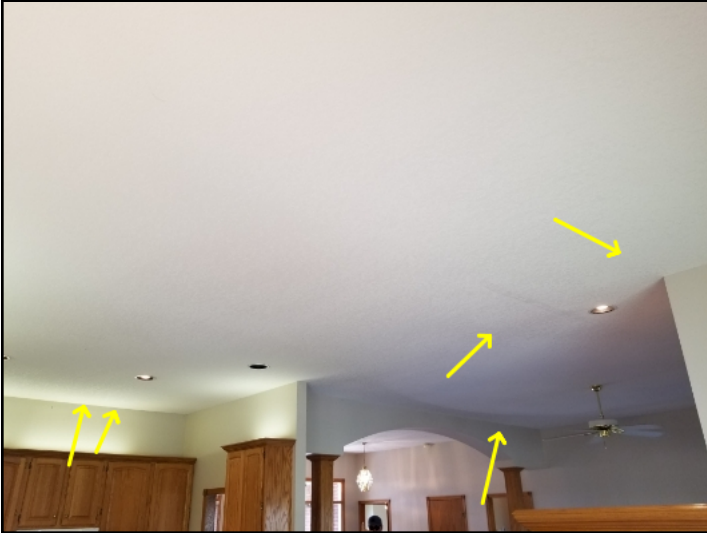
- Small stains noted on the ceiling in the living room, kitchen, master bedroom, basement family room, basement storm shelter, and basement west bedroom at the time of inspection. All staining tested dry at the time of inspection and it is recommended to monitor the location for future leaking and repair if needed.

Ceiling stains in the kitchen and living room.

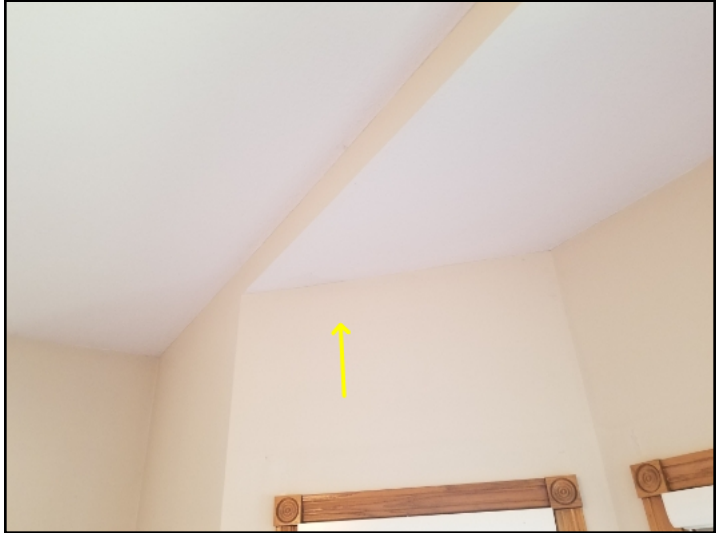
Ceiling stain in the master bedroom.

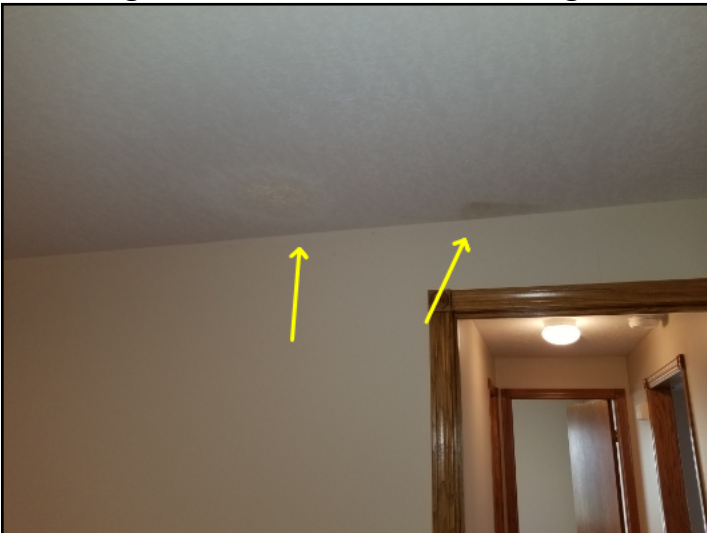
Ceiling stain in the basement west bedroom.

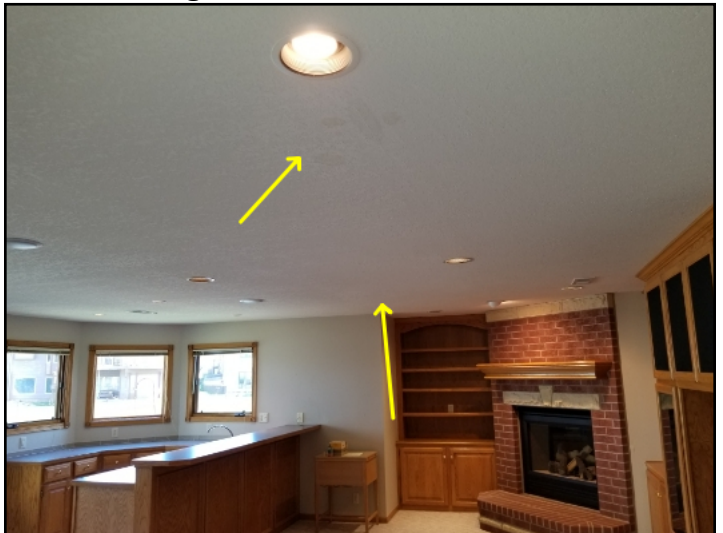
Ceiling stain in the basement family room.

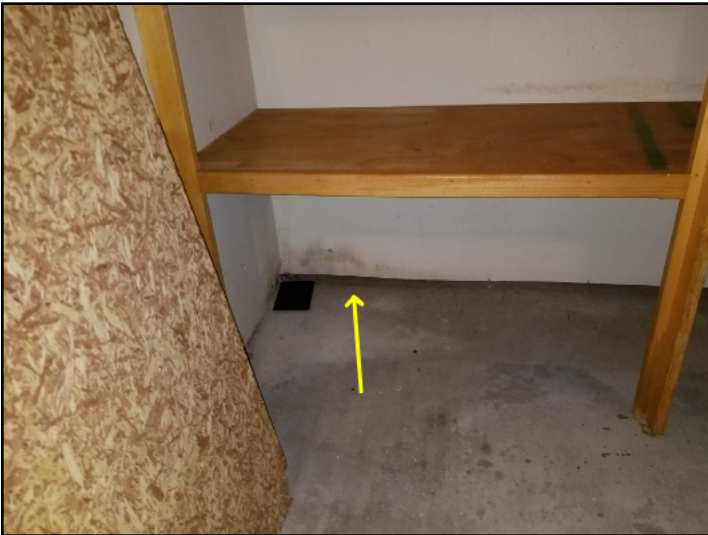
Staining in the basement storm shelter.

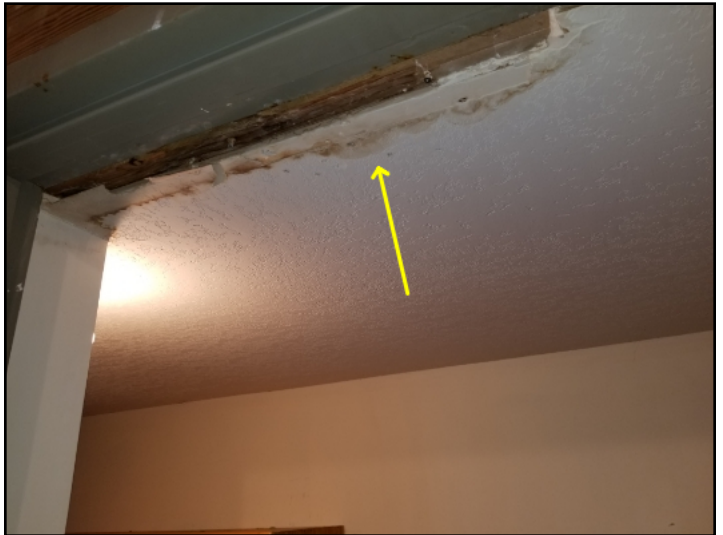
Staining in the basement storm shelter.

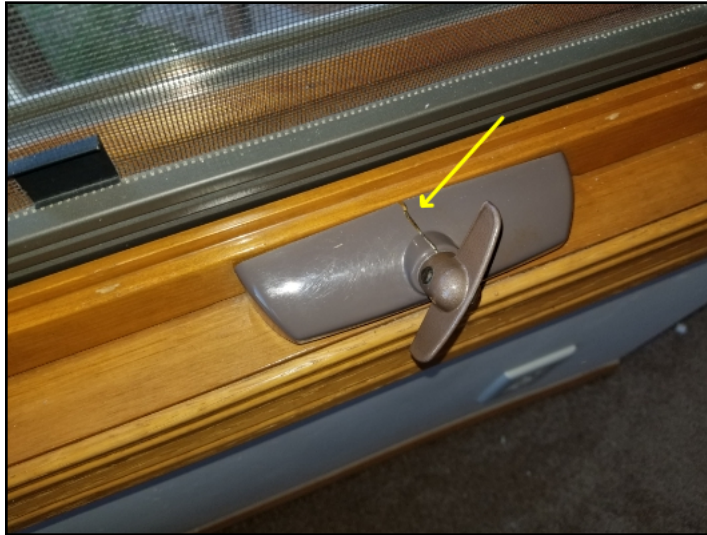
- The crank mechanism cover on the south window in the master bedroom, and the south window in the upstairs living room was broken at the time of the inspection. It is recommended to repair, or replace prior to close.

Example of a broken crank mechanism housing and the master bedroom.
