O.M.T. Inspections, LLC

Property Inspection Report

123 Fake st, Wichita, Kansas 67205
Inspection prepared for: Doe John
Date of Inspection: 6/12/2014 Time: 11:00 am
Age of Home: 2000 Size: 2600
Weather: rainy

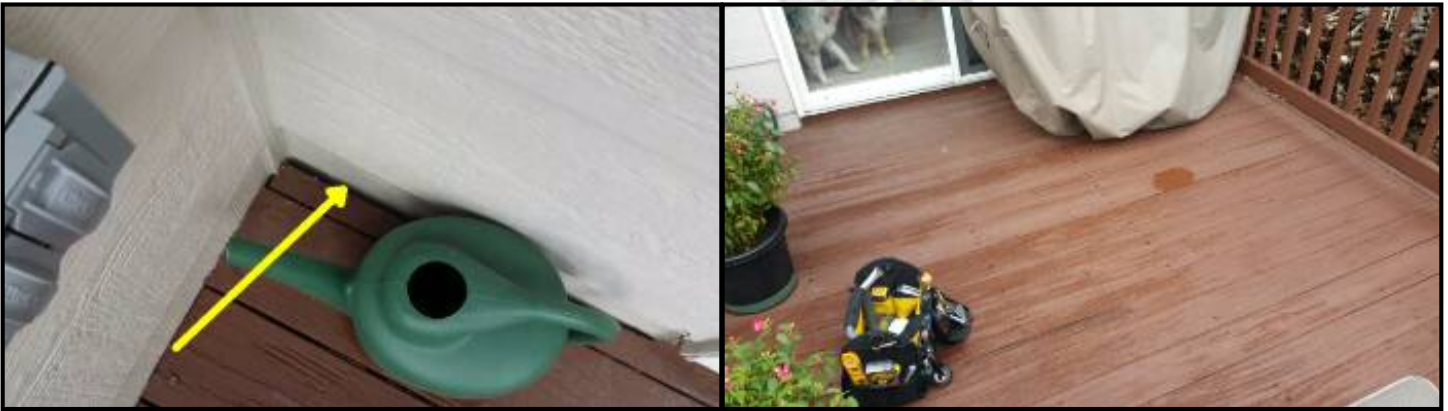
- Deck ledger board lacking flashing. Flashing protects the ledger and keeps water away from the side of the house. Repair as needed.
- Wood to Soil Contact at deck supports. Deterioration may occur and insects may gain access to wood.
- **Joist deck hangers are missing nails. Have all missing nails/screws added as needed.**

Missing flashing.

Grounds		
Page 5 Item: 4	Patio and Porch Deck	<ul style="list-style-type: none"> • Joist deck hangers are missing nails. Have all missing nails/screws added as needed.
Page 6 Item: 5	Stairs & Handrail	<ul style="list-style-type: none"> • The stairs railing is placed to far up. The railing should be lowered to only allow a 6 inch gap between it and the stairs. • The stairs have open risers. This is a safety hazard and should be corrected. Open risers are only permissible on stairs that rise no more than 4 inches. It is recommended to close the risers in per standard building practices. • The railing around the deck as well as the stairs railing have started to separate from the posts. It is recommended to reattach the railing to prevent them from giving way when a load is applied to them.
Attic		
Page 14 Item: 5	Exhaust Vent	<ul style="list-style-type: none"> • Exhaust fan ducts for the bathrooms appeared to terminate in attic. This is a condition that is conducive to microbial growth. It is recommended to have all exhaust ducts that terminate into the attic space rerouted to the exterior per standard building practices.

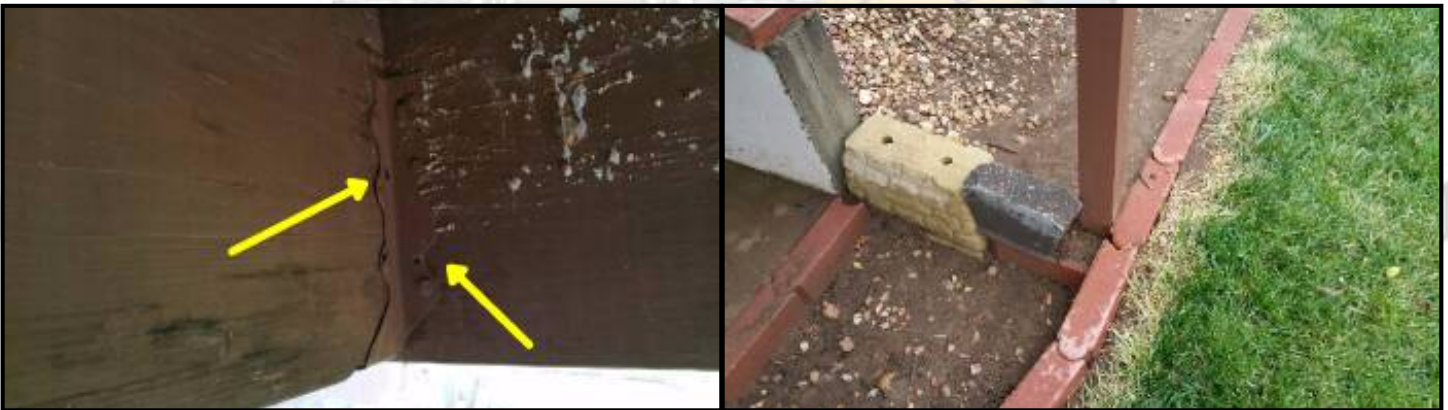
Missing nails in the joist hangers.

Wood in contact with the earth deteriorates faster.

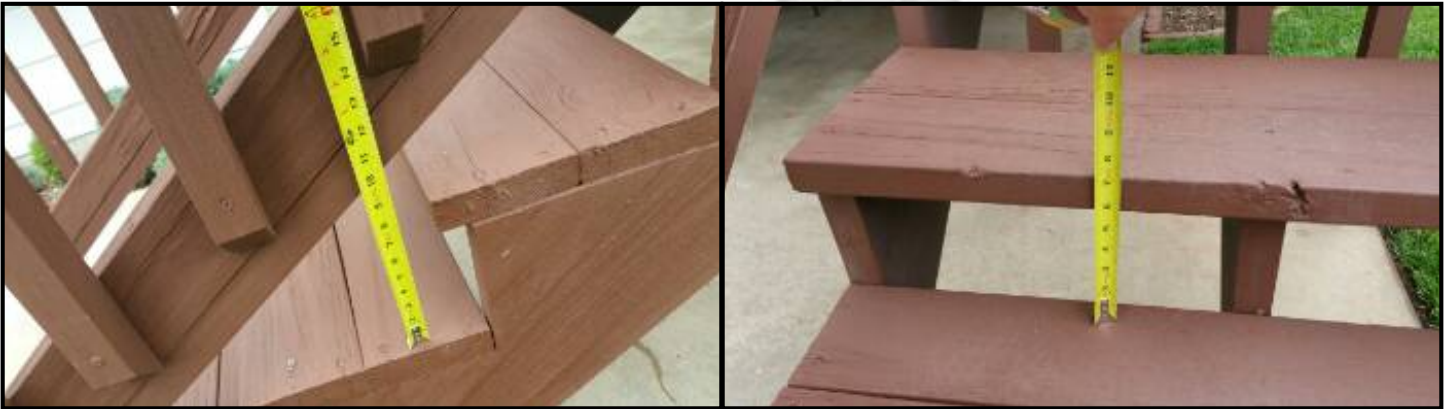
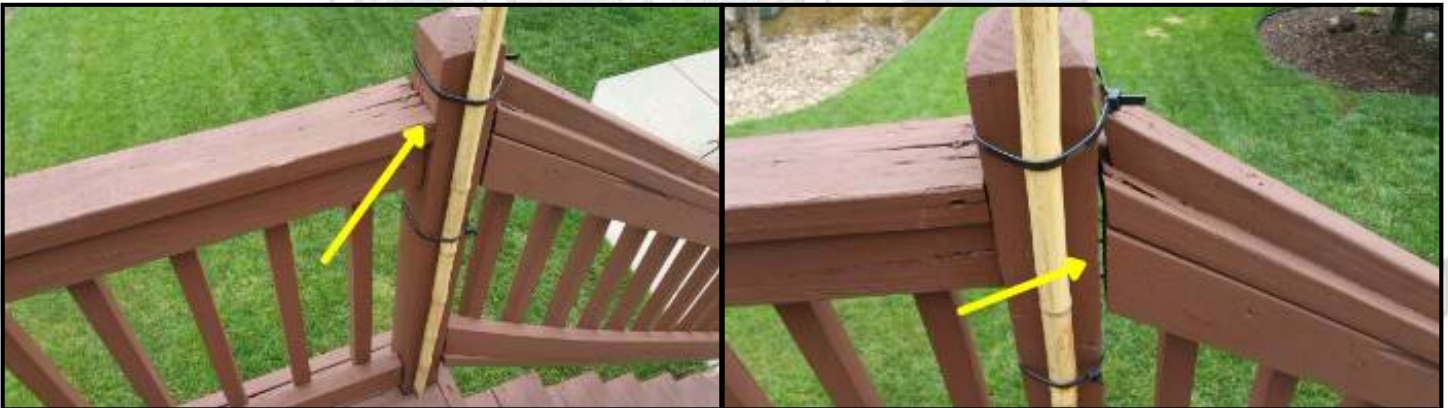
- The stairs railing is placed to far up. The railing should be lowered to only allow a 6 inch gap between it and the stairs.
- The stairs have open risers. This is a safety hazard and should be corrected. Open risers are only permissible on stairs that rise no more than 4 inches. It is recommended to close the risers in per standard building practices.
- The railing around the deck as well as the stairs railing have started to separate from the posts. It is recommended to reattach the railing to prevent them from giving way when a load is applied to them.

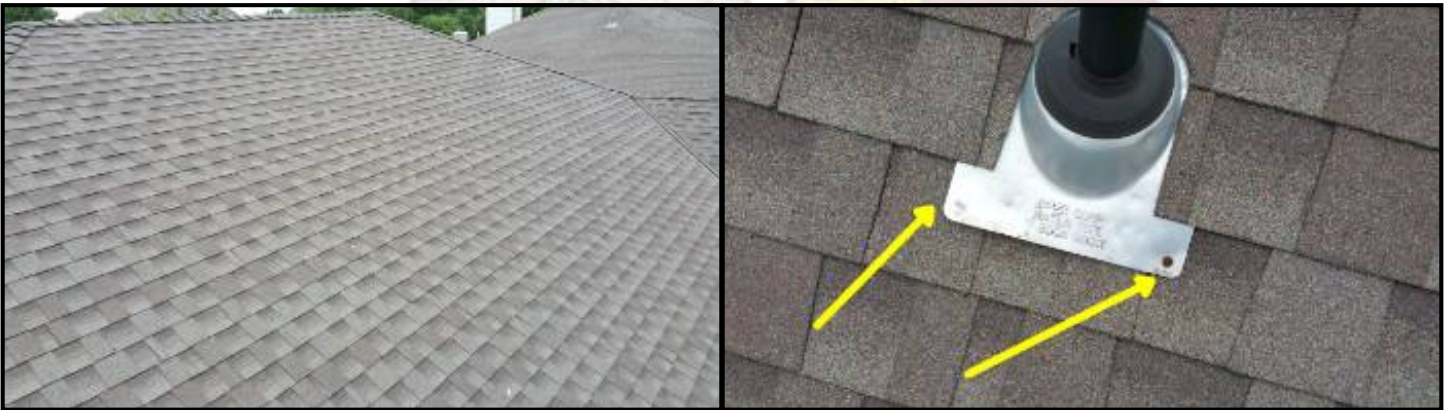
- Moss was noted on a small portion of the roof. This can lead to the premature failure of that portion of the roof and subsequent leaks. Recommend treating moss during its growing season (wet months) with a moss killer. For information on various moss treatment products and their pros and cons, visit <http://bryophytes.science.oregonstate.edu/page24.htm>.
- Exposed nails on roofing material. Recommend sealing all fastener heads.

A nail is missing in the flashing and all others need to be sealed.

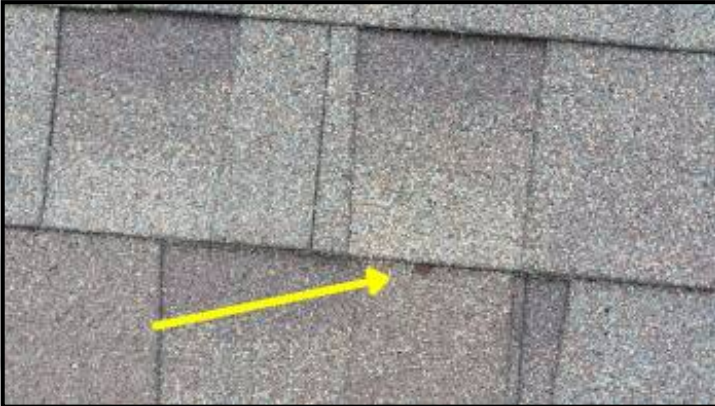
Exposed nail head on the south side of the roof.

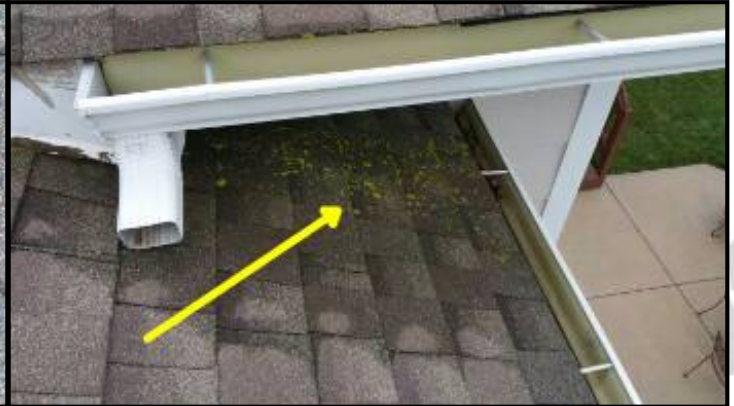
Moss growing on the roof

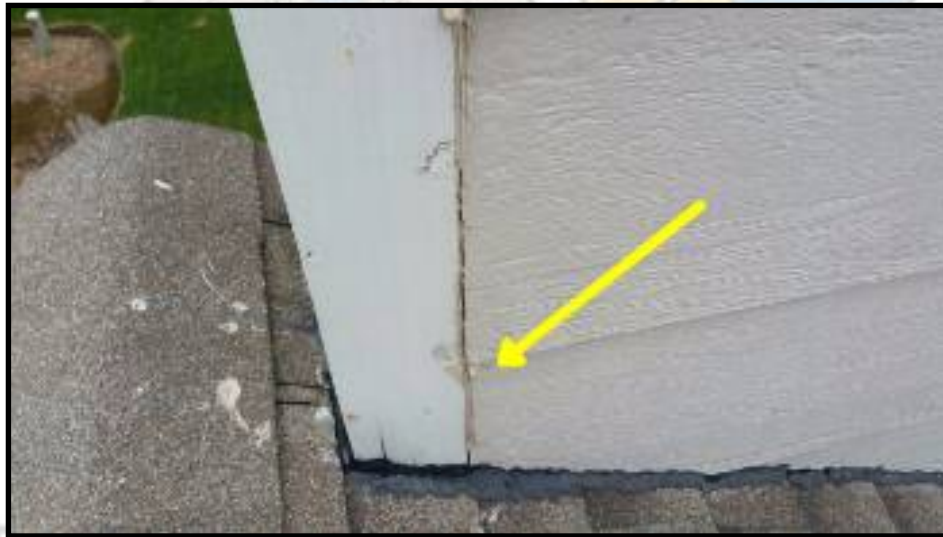
- Some minor siding deterioration noted. It is recommended to caulk all areas of the chimney.

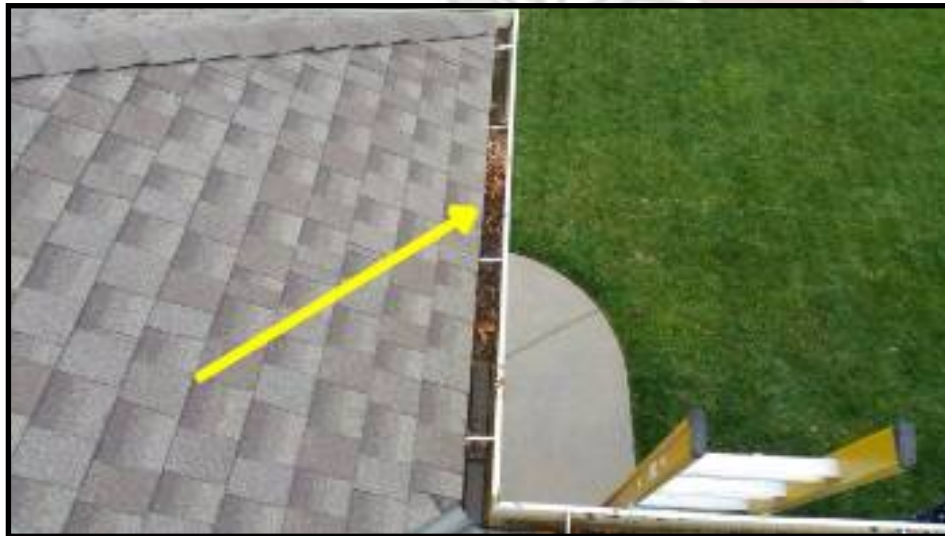
- **Maintenance issue: Clean gutters, a significant amount of debris was discovered in a portion of the gutters. This can cause rain water to over flow or back up the roof surface.**

The gutters are clogged with debris.

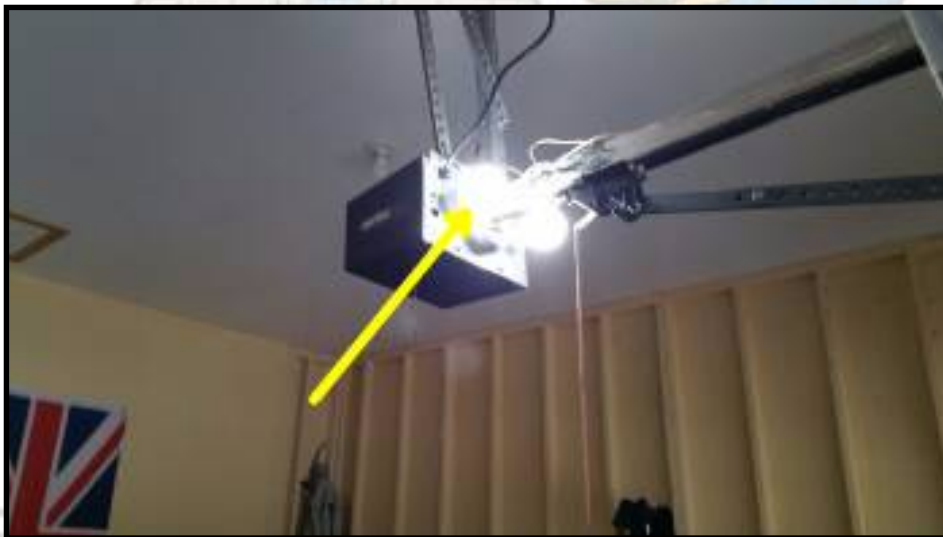
- Appeared functional using normal controls, at time of inspection.
- Chain drive opener noted.
- The opener is missing cover for bulb/light. Recommend replacing it to prevent damage to the bulbs.

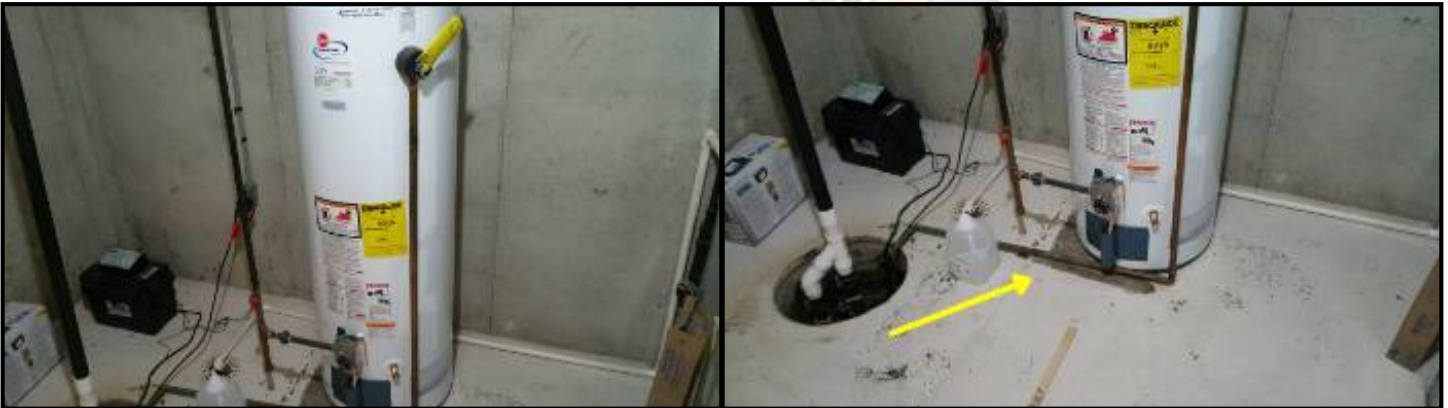
- The TPR valve drained into the sump. It is recommended that the drain pipe be cut 6 inches off of the floor and have it drain to a separate container.
- The water heater was able to produce hot water for the duration of the inspection.

TPR valve draining into the sump pit.

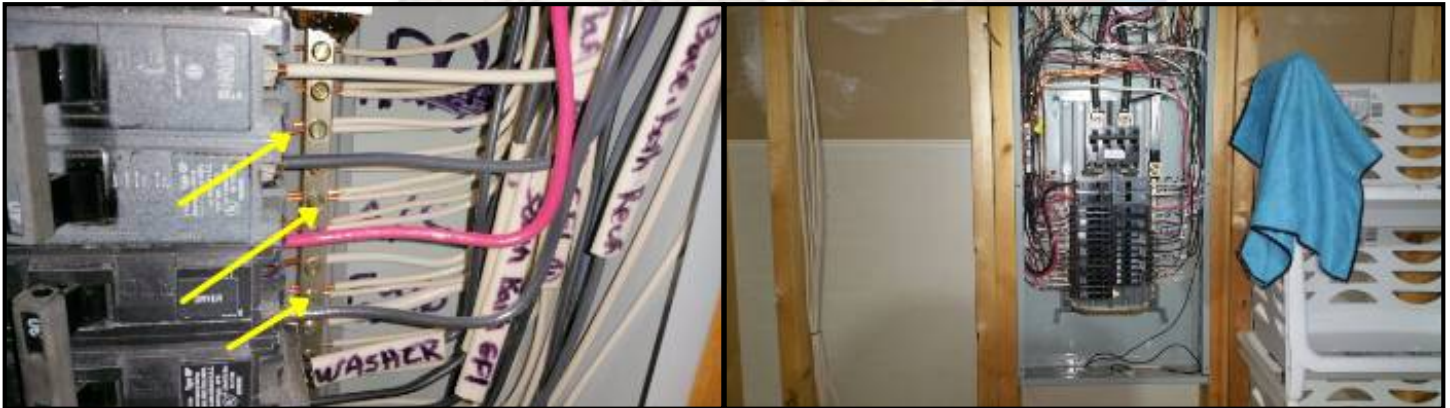
- **Neutral wires were doubled under the same lug. All neural wires should be under their own lug. It is recommended to have a qualified electrical contractor repair per standard building practices.**

Double tapped neutrals.

Electrical		
Page 26 Item: 1	Electrical Panel	<ul style="list-style-type: none"> • Neutral wires were doubled under the same lug. All neural wires should be under their own lug. It is recommended to have a qualified electrical contractor repair per standard building practices.

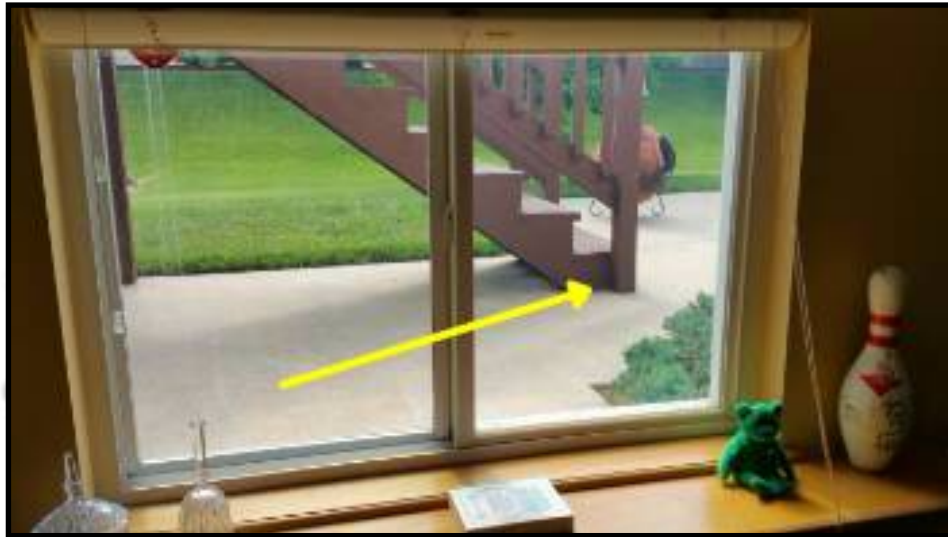
- Missing screens observed at all windows in the basement.

Missing screen in a basement window.
